The Parthenon restoration work was divided into twelve programs. Initially the interventions were only of a rescue character, but gradually evolved into interventions for the enhancement of the monuments and the archaeological site.

THE PARTHENON 6

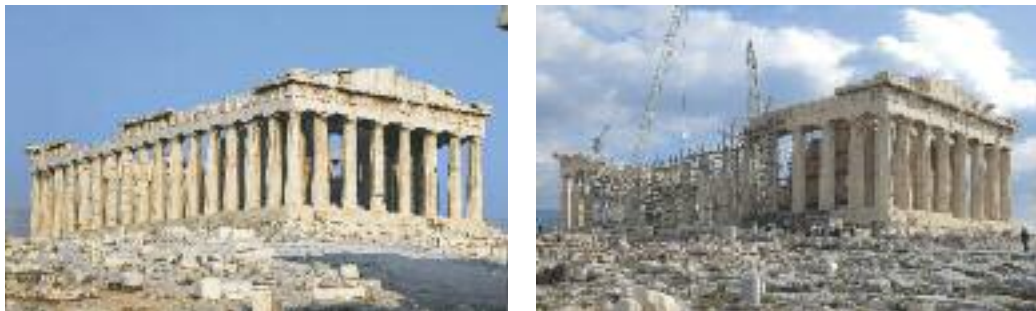
View of the northwest side of the temple before and during the works.

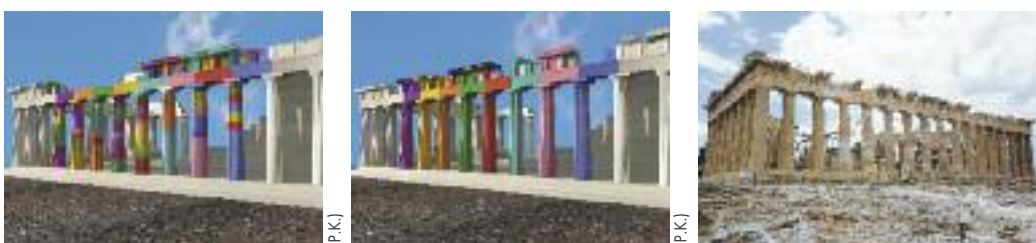
Digital imaging of the north colonnade, with different colours indicating the misplaced drums before the restoration, and after repositioning in their original places.

In the north colonnade, eight columns and their entablature, which had been misplaced, a total of 230 architectural members weighing 900 tons, were dismantled in order to be repaired and to be returned to their initial positions in the monument. All of the cement drums from the 1923-33 restoration were replaced with new ones of Pentelic marble. Most of the metopes were transferred to the Museum, while copies in artificial stone were set on the monument.

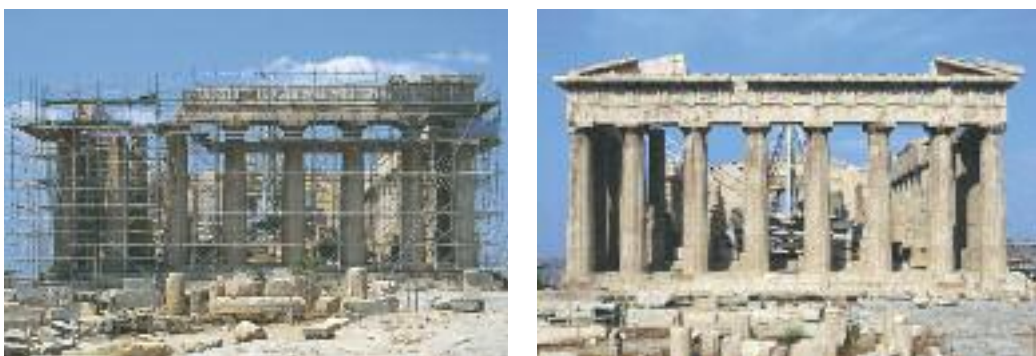
The east façade of the Parthenon during and after completion of restoration.

On the east side 160 architectural members were dismantled. They underwent repairs and conservation work and were returned to their positions. All of the metopes were removed and transferred to the Museum, while on the monument they were replaced with copies of artificial stone.

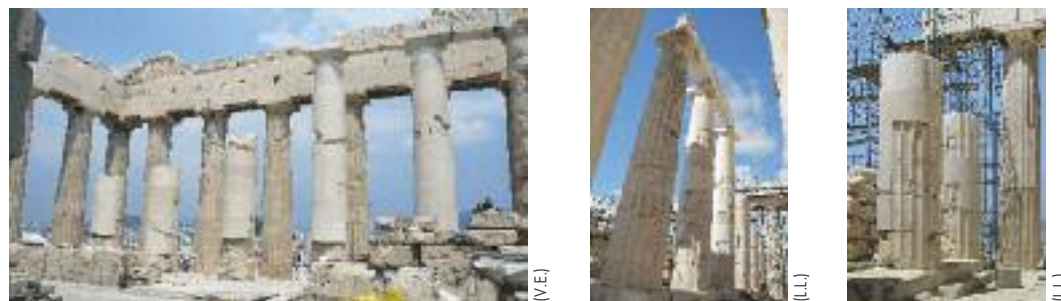
The pronaos of the Parthenon during the restoration.

In the pronaos colonnade which retained only one column, two columns were restored in full and three partially. Drums and fragments that were lying on the ground and supplements of new marble were used in the restoration.

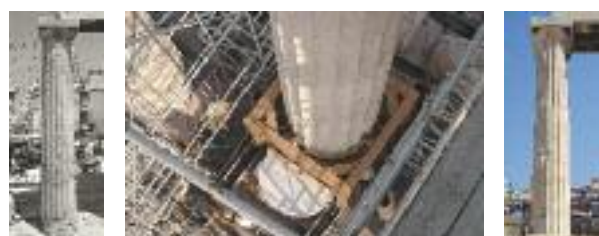
The fifth column from the east on the south side before, during and after the restoration.

In 1993, the fifth column from the east on the **south side**, which was in danger of collapse, was restored after the overlying entablature was dismantled, and the entire column from the second drum upwards was removed so that the lowest drum could be filled and restored to a stable state.

The lower drum of the fifth column from the east, on the south side, was supplemented with new marble after the temporary removal of the entire upper portion without disturbing the order of the drums which comprised it.

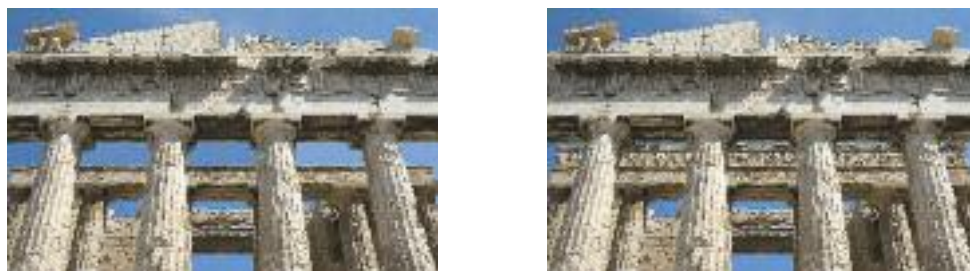
The west façade of the Parthenon during the intervention and after completion of the restoration.

Approximately 130 architectural members from the opisthonaos were dismantled, repaired and returned to their positions. All the frieze blocks were removed and transferred to the Museum, while copies in artificial stone were put in their place on the monument.
