The Parthenon restoration work was divided into twelve programs. Initially the interventions were only of a rescue character, but gradually evolved into interventions for the enhancement of the monuments and the archaeological site.

THE PARTHENON 6

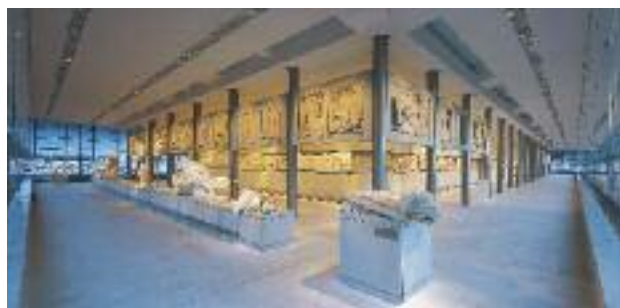
The original sculptures as well as copies of those that are today in the British Museum are exhibited in the Acropolis Museum in positions analogous to their original locations on the temple.

View of the Parthenon Gallery in the Acropolis Museum. (A.M.)

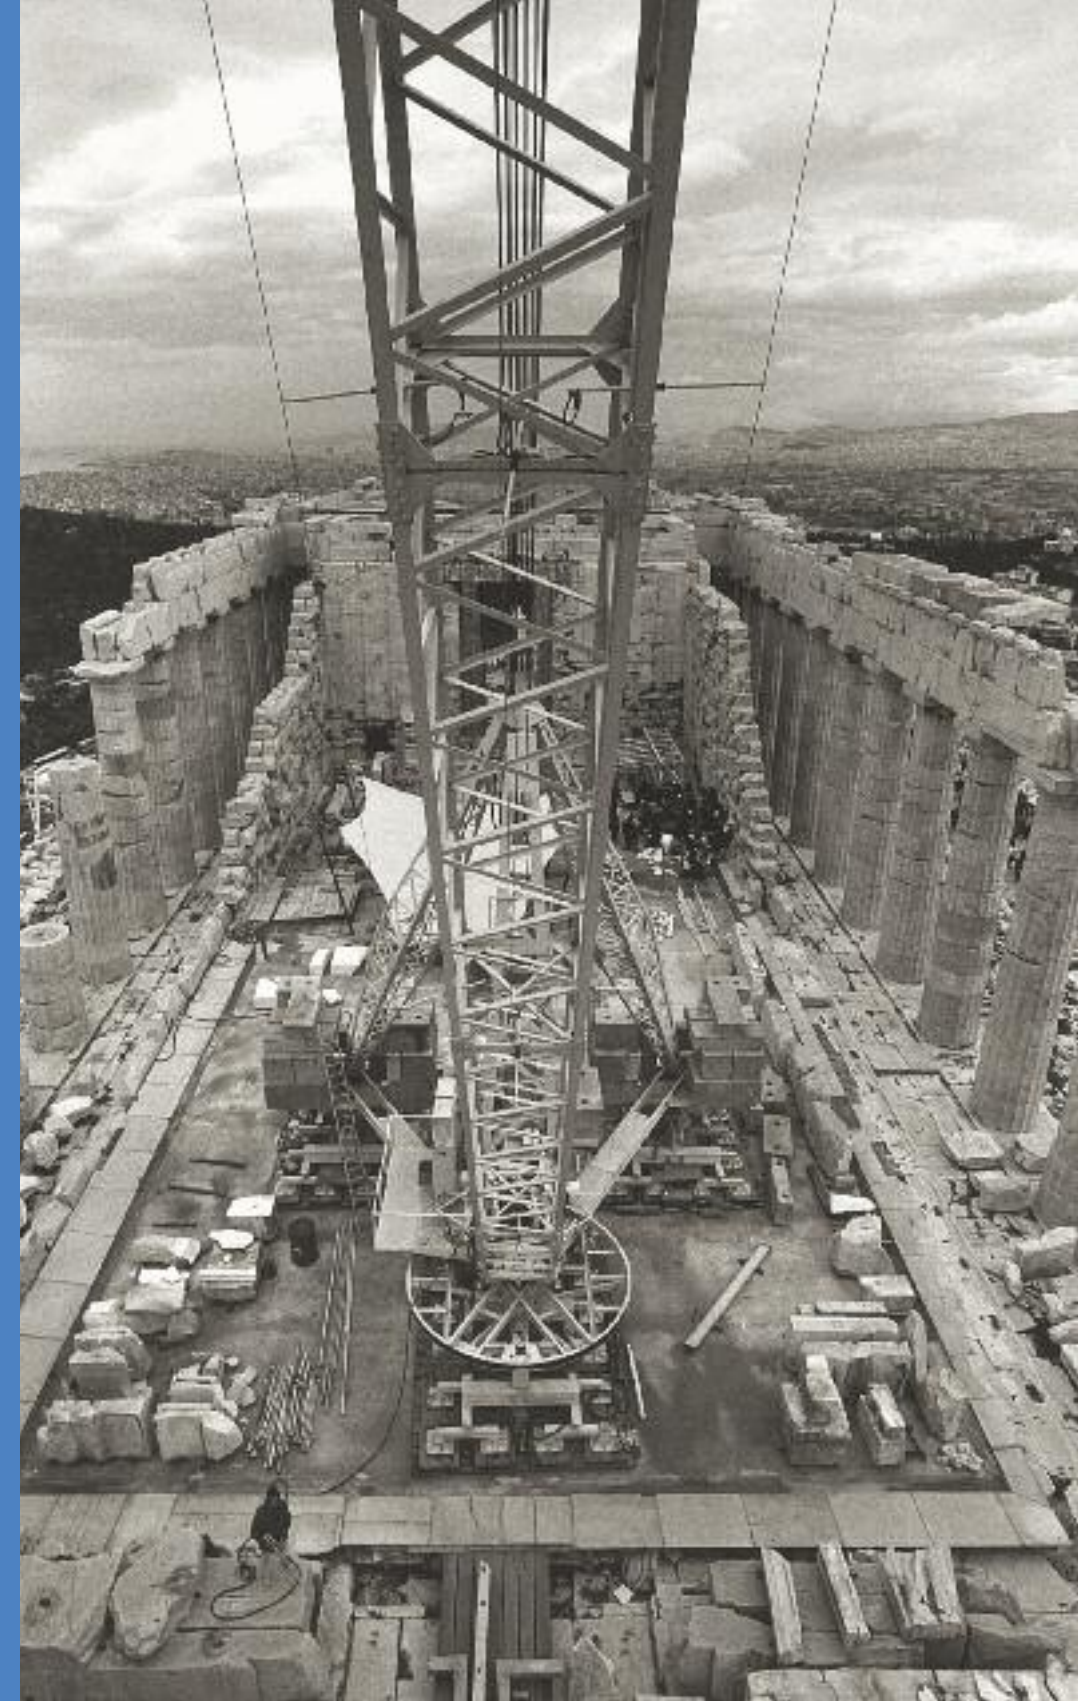
The work-site within the cella of the Parthenon, dominated by the rotating crane.
